The Locomotive

THE HARTFORD STEAM BOILER INSPECTION AND INSURANCE CO.

VOL. XXIX.

HARTFORD, CONN.
1912-1913.

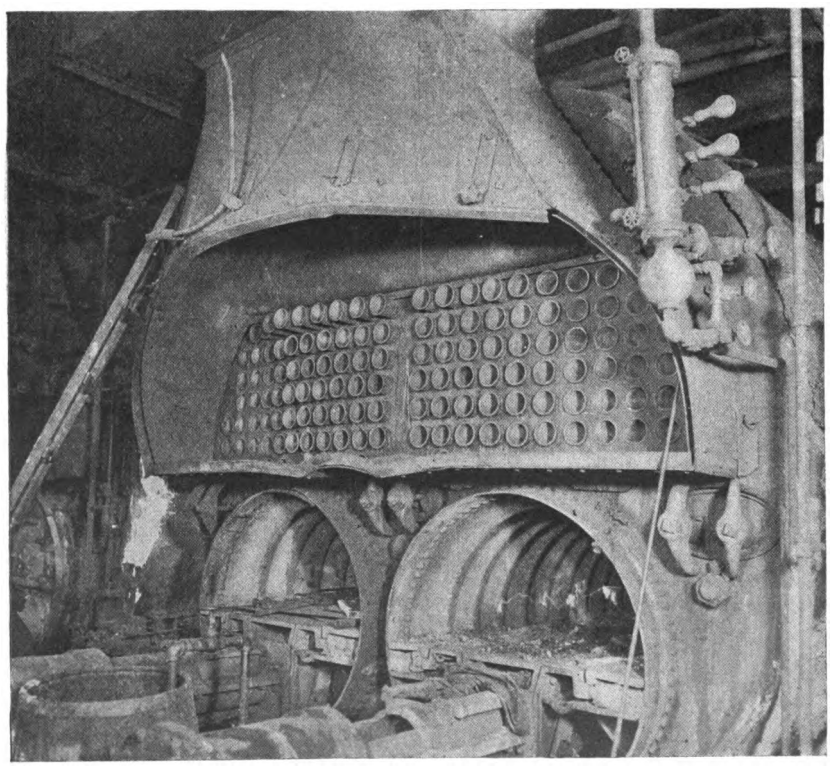
FIG. 1. DAMAGED FRONT OF BOILER.

From the data at hand the cause of this overheating cannot be definitely determined, but the boilers were reported clean, and if such was the case, forced driving or low water was probably responsible. Sheet "B" was thrown forward against the rear tube sheet "D" with such force that it drove a number of tubes through the front head, some of them extending as much as six inches from its face. This is shown on the accompanying view of the front of the boiler.

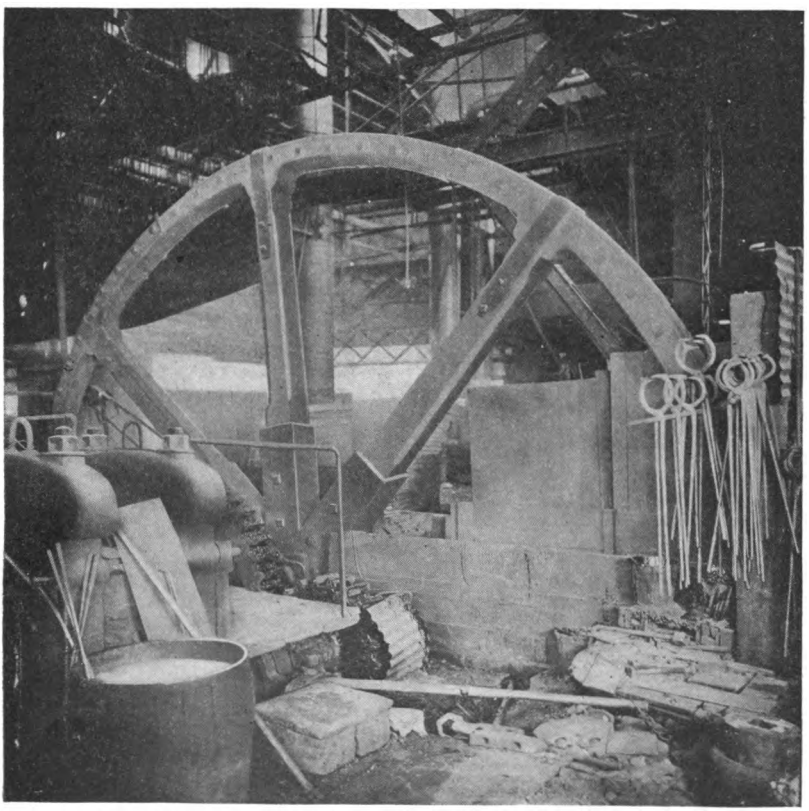
An Old Fly-Wheel.

The illustration on the front cover of this issue of THE LOCOMOTIVE shows the wreck resulting from the failure, May 10, 1912, of a fly wheel on an engine of the high speed, simple, automatic type. The engine in question was a 12" x 12", center crank, and was belted to a generator at the Higginsville, Mo., electric light plant. This illustration is of particular interest, because of the wide-spread notion among engineers, that engines of the "automatic" shaft governed type cannot run away. A somewhat similar instance was recorded in THE LOCOMOTIVE for April, 1911.

It would appear that in this case the governor pulley failed first, and we are told that fragments went through the roof with considerable violence. This failure may have been hastened by a blow delivered to the rim of the wheel by the governor weight. When relieved of the first wheel, the engine seems to have slewed around on its foundation, fouling the other pulley on the sub-base, and shearing its spokes free from both the hub and the rim. This rotation of the whole engine is in the right direction (left handed), to be explained by the principles of gyroscopic motion. If we consider the crank shaft balanced for weight by the two wheels, when running normally, it would become immediately unbalanced by the failure of one of them. This failure would probably occur at high speed, and so is favorable to such an assumption. It is of course well known to those who have experimented with the simple gyroscopic tops of their school days, that if the wheel is spinning, the top may

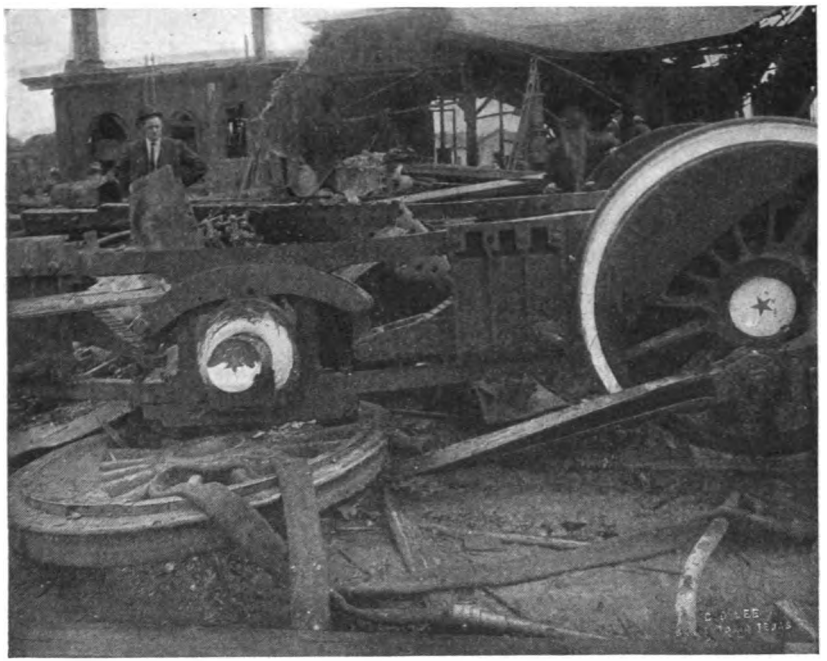
FIG. 3. DRIVER BLOWN FROM AXLE.

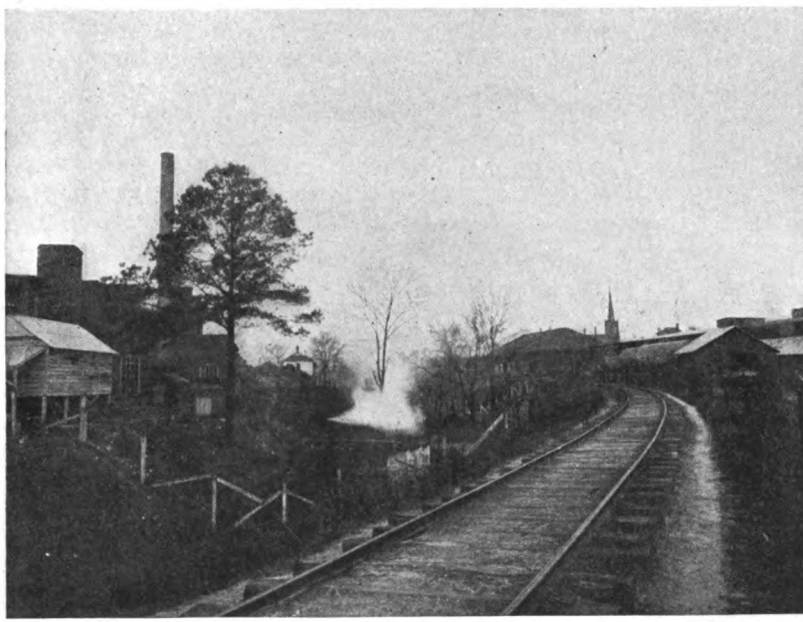
FIG. 1. THE OIL TANK, RAILROAD AND BOILER HOUSE.

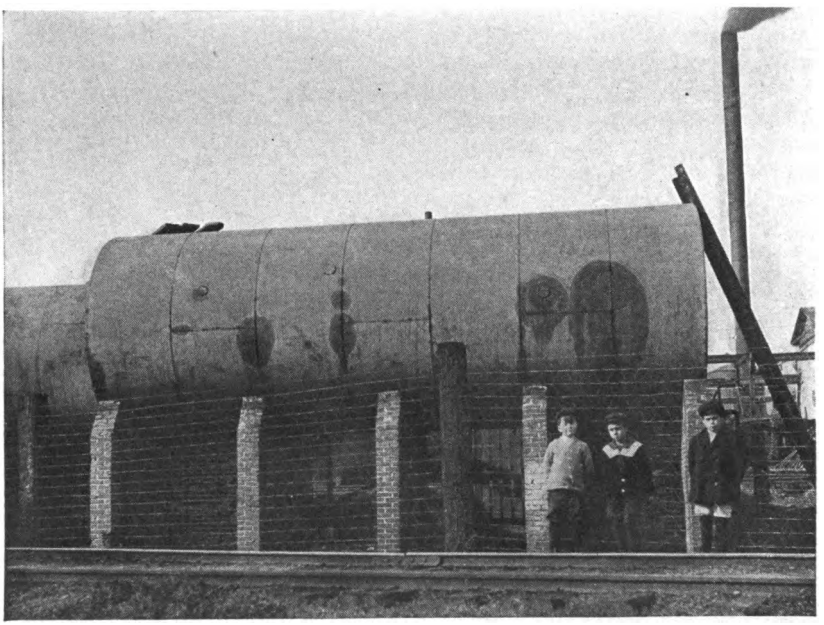
FIG. 2. THE PATCHED OIL TANK.

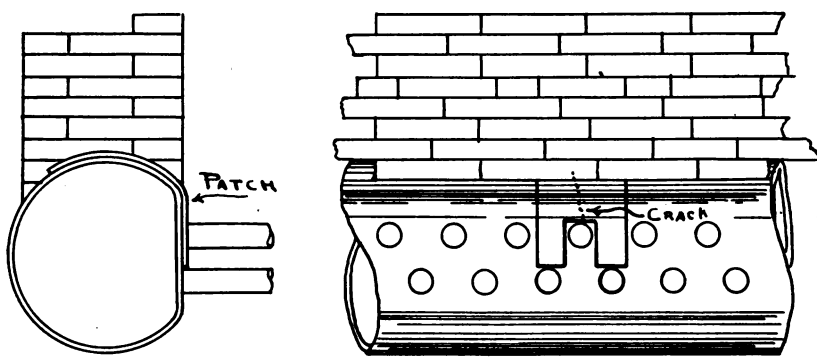
FIG. 2. PATCH BRICKED AND CEMENTED IN PLACE.

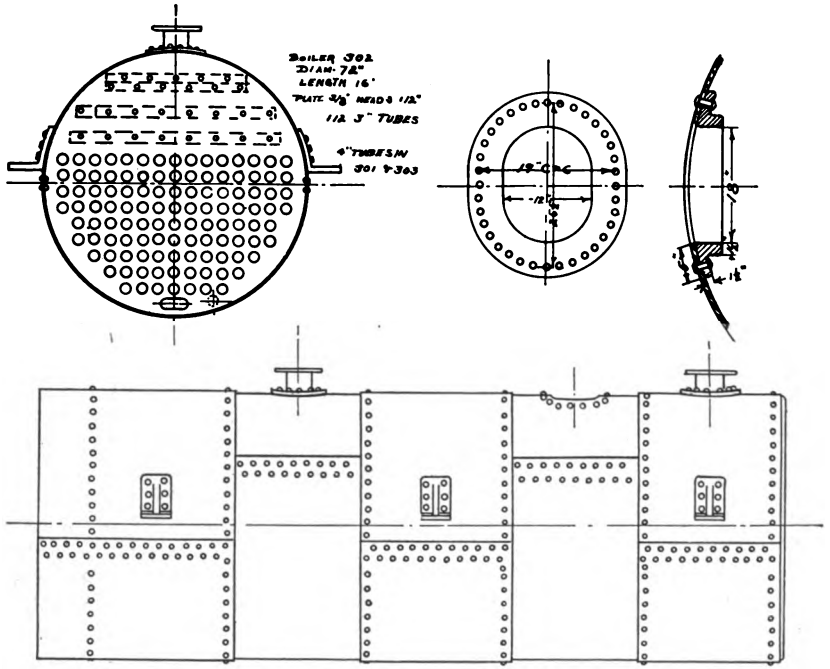
FIG. 1. DETAILS OF BOILERS 301, 302, AND 303.

The report of the HARTFORD's inspector shows that these boilers, aside from age were in apparent good order. There was evidence that no rivets had been replaced, and that the seams had never been chipped and caulked. No fire cracks were visible, and although there was a slight indication of overheating on the bottom sheets of the rear courses, this was considered trivial. The only repairs known to have been made, were several complete renewals of the tubes.

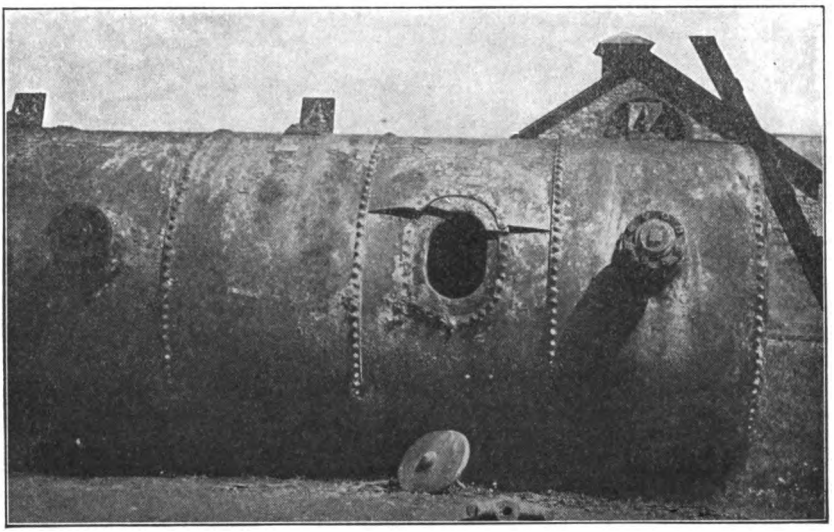
FIG. 2. SHOWING THE BROKEN MANHOLE FRAME OF BOILER 302.

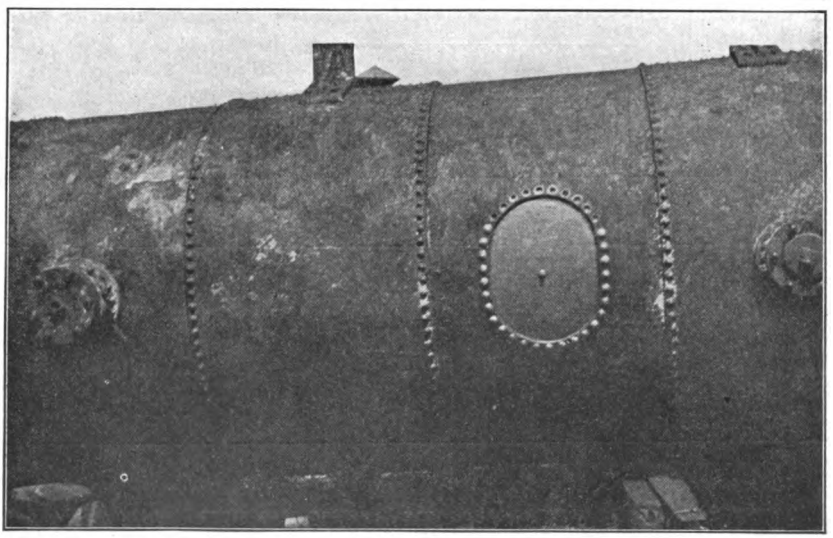
FIG. 3. APPEARANCE OF BOILER 303 AFTER TESTING.

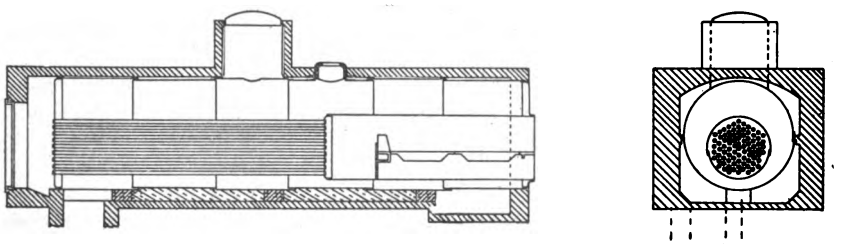
Creusot, and were of the type illustrated in Fig. 6, cylindrical, with internal furnaces and direct tubes, surmounted by a dome. The settings were such that the products of combustion passed first through the tubes, then returned under the right-hand side of the shell to the front, where they passed across, and back to the flue, under the left-hand side of the shell. A longitudinal baffle wall for this purpose was provided under the center line of the boiler as is indicated in Fig. 6. The boilers were designed for a pressure of 71 lbs., but were later tested and worked at 78 lbs. (5.5 kg. per sq. cm.). They had a heating surface of 1270 sq. ft., were oil fired, and forced day and night except Sundays, for more than 30 years. In 1900 the rate of firing, which is typical of the service they rendered throughout their life, was such as to consume about 150 kg. of oil per sq. meter of grate per hour, which is equivalent to 31 lbs. of oil per sq. ft. of grate per hour, a very high rate indeed. The evaporation obtained was about 6 lbs. of water per lb. of fuel. The material of which the boilers were constructed was Creusot wrought iron, designated by the following numbers: body of the boiler, No. 2; heads, lower furnace sheets, and domes, No. 4; upper furnace sheets and front tube sheets, No. 6. The entire battery was overhauled between 1905 and 1907, as the result of a general breaking down from old age, and has since been entirely replaced. This overhauling however gave the opportunity for obtaining test specimens, and the data given was obtained at this time.

FIG. 6. BOILER KNOWN AS S-3.

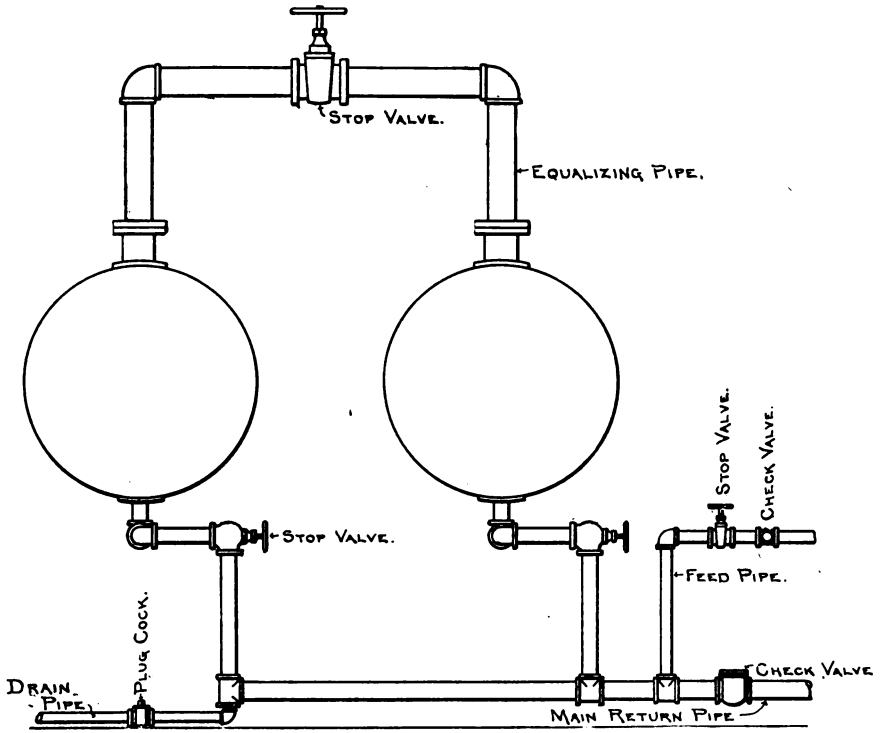
The return pipes of the various boilers should be connected to a common return line, with stop valves for each boiler. A check valve should be placed in the return line on the building side of the branches to the boilers as shown in Fig. 1, to prevent water flowing back to the radiators and piping when the main steam valve is closed, as discussed in the October 1912 LOCOMOTIVE. There

FIG. 1.—ARRANGEMENT OF RETURNS WITH EQUALIZING PIPE.

should not be any check valves in the branches to the boilers, since the return pipe acts as an equalizer below the water line and should afford a free connection between the boilers at all times unless the special condition described below exists, requiring the closing of the equalizer valves. *If only one of a group of boilers is working on the system, the equalizer must be shut off if the dead boilers are cut off from the steam and return lines. If, however, the dead boilers are still connected to the system whether or not their fires are burning, the equalizer (and return valve) must be open to prevent the dead boilers from filling with water at the expense of the one which is working.* This would probably result in serious over heating of the metal of the working boiler.

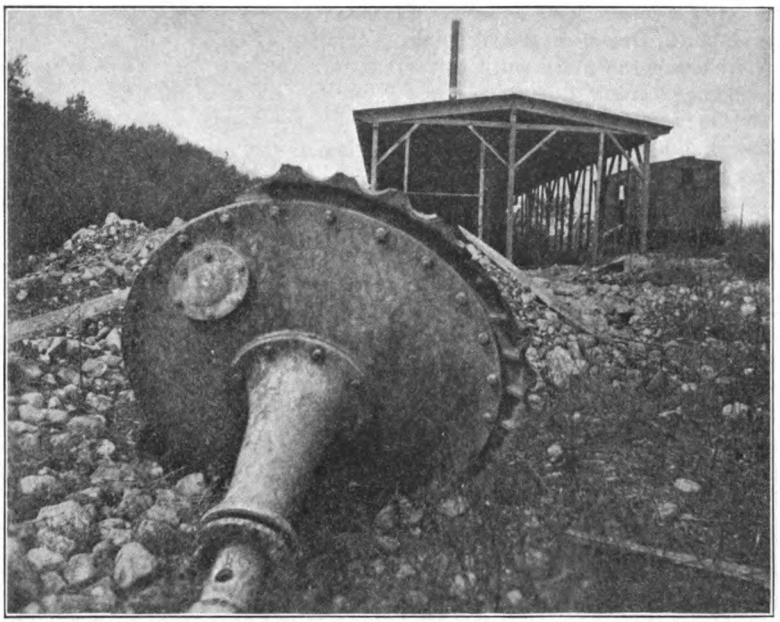
The accompanying photographs show the condition of a rotary drying cylinder after its explosion September 19, 1912, at the plant of the Wenig Feed and Stock Co., Coleman, Ill.

FIG. 2.—OUTSIDE VIEW OF OUTER HEAD.

We are told that in this case, the dryer had been bought at second hand and without inspection. It had developed leaks at the tube ends a few days prior to the explosion which had been repaired by a boiler maker. It is also said that it was not provided with a pressure gage, reducing pressure valve,

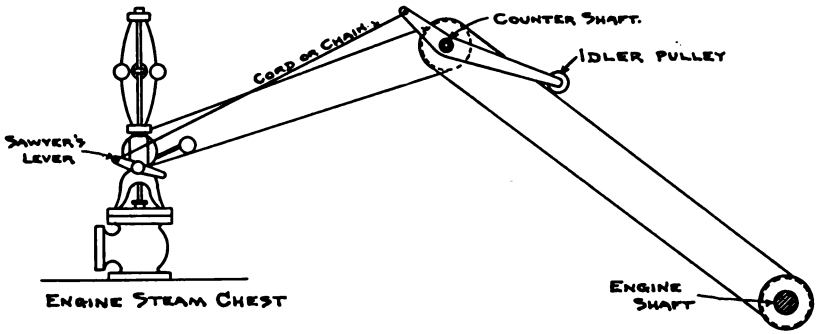
When conditions compel the use of a counter-shaft with an additional belt to drive a throttle valve governor, it is very important that precautions should be taken to insure free action of the automatic safety stop. So that it will stop the engine if either of the two belts should break. So many cases have come under our observation where no provision has been made for such an emergency, that it may be well to call attention to the proper way to connect up governors operated in this manner. Of course, it will be understood that reference is now made to the throttling governor with an automatic safety stop attachment. This safety stop is designed to be operated by an idler pulley, which rides on the governor belt, and is so arranged that should the belt break, the idler will drop to a lower position, thus tripping the safety latch, and allowing the throttle valve to close.

FIG. 1.— SAFETY DEVICE FOR A COUNTERSHAFT DRIVEN GOVERNOR.

When it is necessary to use two belts, as noted above, it is evident that the automatic safety stop on the governor will not operate if the belt that runs from the engine shaft to the counter-shaft should break. In this case, the governor would stop revolving and drop to its lowest position, allowing full steam admission to the cylinder, which would result in the engine racing. To obviate this danger, a second idler pulley similar to the one attached to the governor should be provided to operate on the belt leading from the engine to the counter-shaft, as shown in the accompanying sketch. This can be fitted with very little trouble or expense by the engineer or other mechanic about the plant, as the outfit only consists of the pulley and arm with cord or chain to attach to the Sawyer's lever on the governor, which also operates the safety stop. When thus connected, the governor can then be relied upon to stop the engine if either of the belts break.

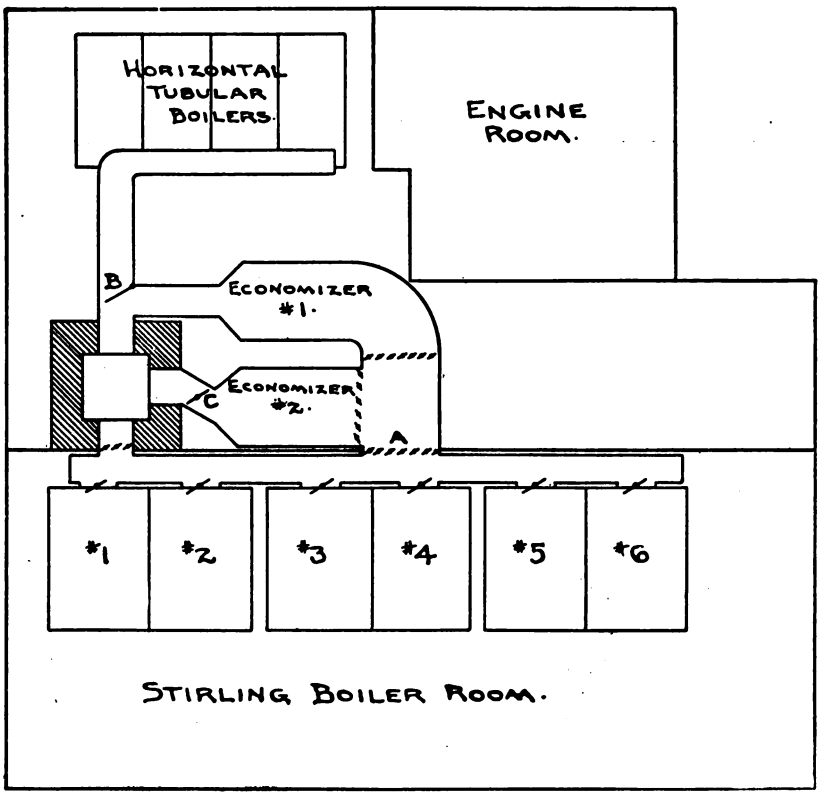
FIG. 1. PLAN SHOWING ARRANGEMENT OF BOILERS AND ECONOMIZERS.

The arrangement of the boiler house and its equipment, as it existed before the accident, is shown in our sketch plan, Fig. 1. There were two boiler rooms, one containing six 325 horse-power Stirling boilers, and the other containing the stack, the economizers, and a battery of four horizontal tubular boilers, together with the feed heaters, pumps, fans, fan engines, and other boiler room auxiliaries. As will be seen, only the gases from the Stirling boilers could pass through the economizers, while those from the tubular boilers went direct to the stack. The economizers, two in number, were behind the stack, and side by side, parallel to the division wall. They rested on a platform about 10 feet above the floor. This platform consisted of longitudinal I beams, between which were turned brick arches, and these in turn rested on transverse I beams,

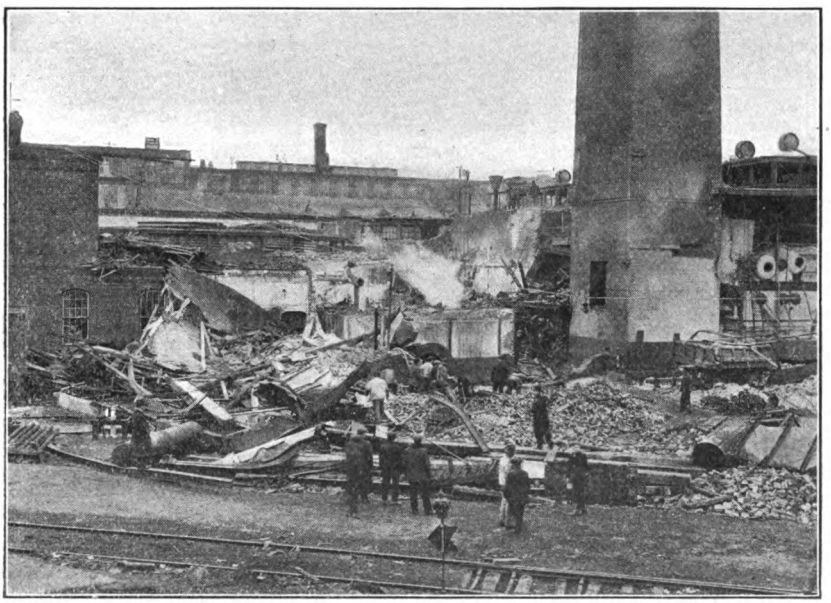
FIG. 2. GENERAL VIEW OF THE WRECKAGE.

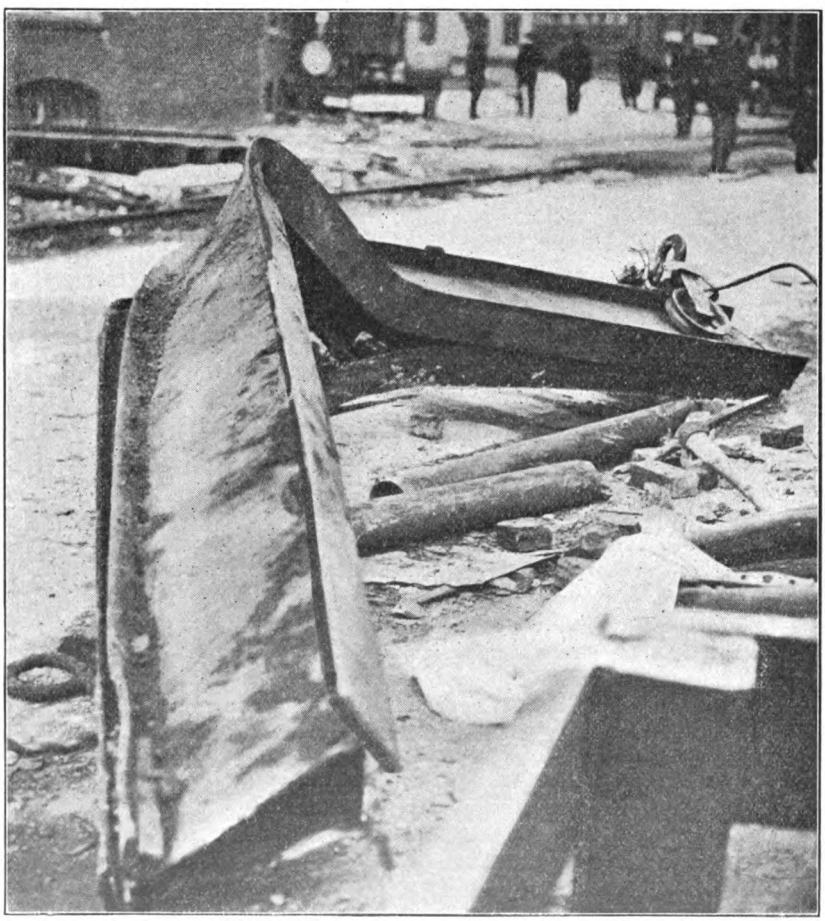
FIG. 3. 15-INCH "I" BEAMS BENT BY THE FORCE OF THE EXPLOSION.

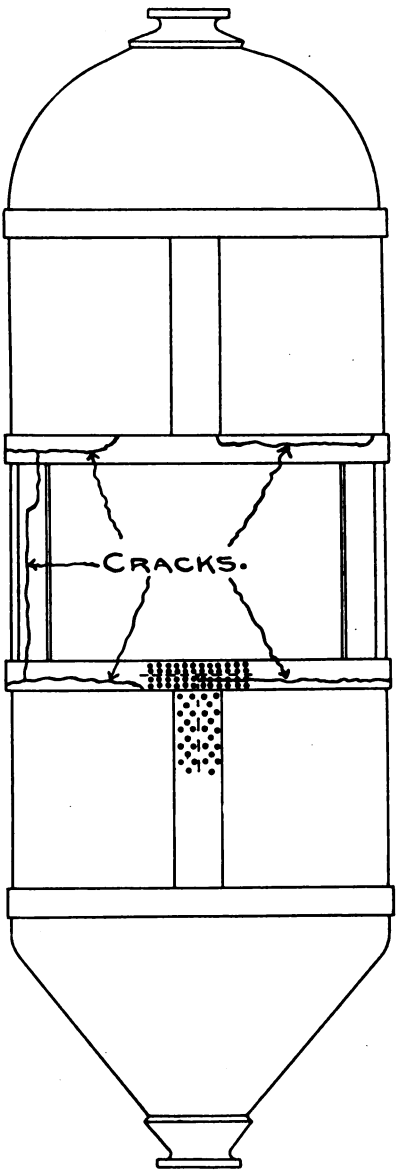
FIG. 3. ELEVATION OF DIGESTER SHOWING LOCATION OF THE LINES OF FAILURE.

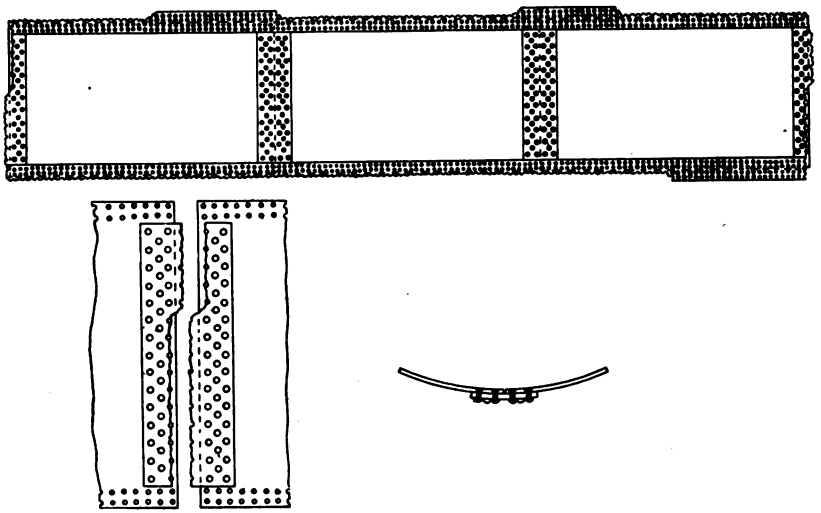
FIG. 4. DETAILS OF COURSE WHICH FAILED.

plates had failed by cracking along the line of the rivet holes, and from the direction in which the exploded sheet was thrown, it was evident that this cover plate was the place of initial failure. In tearing from the other sheets, in every case cover plates failed while the sheets themselves did not. This is well brought out in Figs. 3 and 4, which show the way in which these cracks ran along the straps. As these plates were thicker than the sheets and should have been expected to withstand the greater strain, their failure to do so suggested an inferiority of material which an analysis has confirmed. Fig. 5 shows one other strap on this course which cracked but did not let go. Strangely enough the interior of the steel shell showed no corrosion. The lead lining, in this case at least, seems to have protected the steel thoroughly.

The fact that the cover plates of the joints gave way as we have described, and that a close examination discovered evidence of similar cracks in the straps of other digesters will arouse renewed apprehension in the minds of owners and insurance companies for digesters of a similar construction built from twelve to twenty years ago.

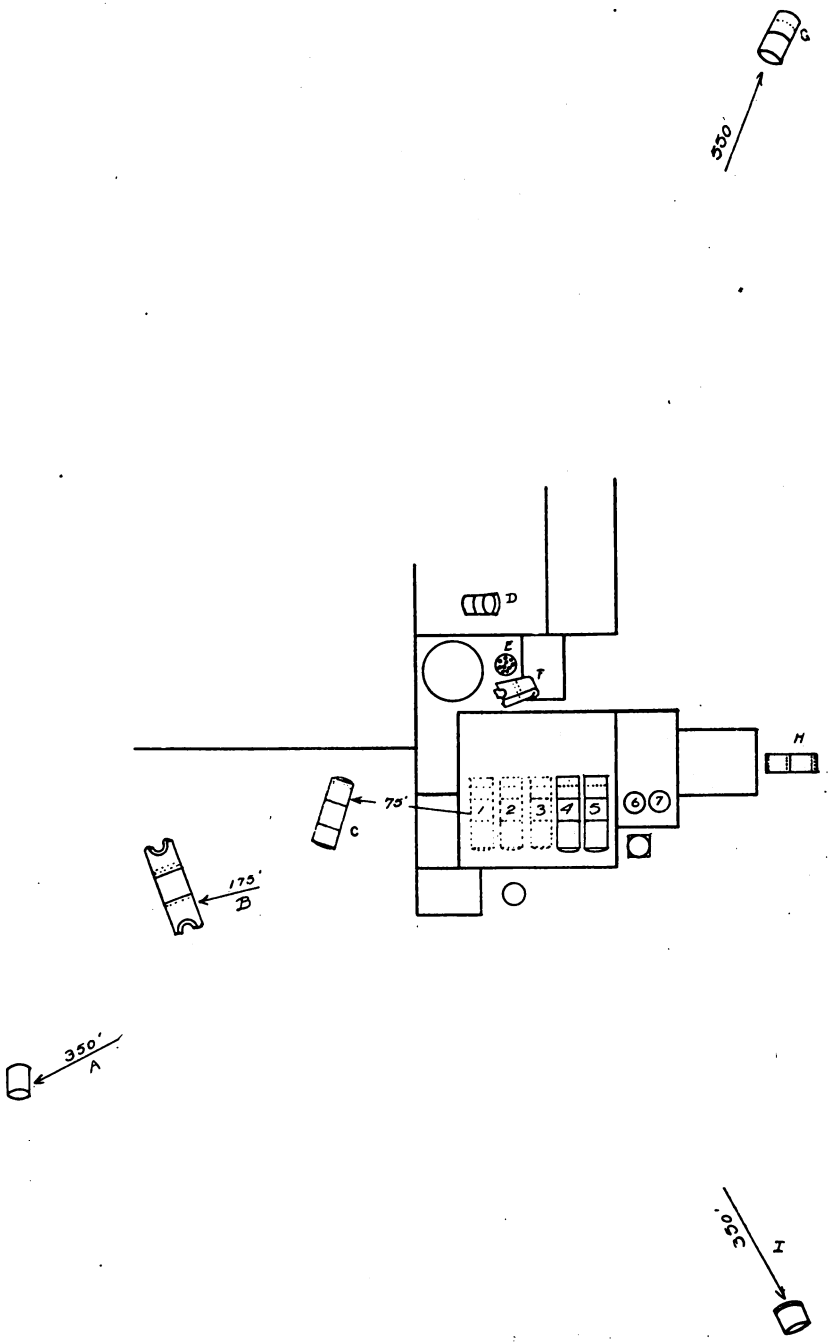
There is some doubt as to which of the boilers first gave way. Witnesses testified to a double report like two pistol shots in rapid succession. It is probable, from the appearance of the failures, that one of the boilers exploded first, and struck its neighbor a blow of sufficient violence to set it off. Both the exploded boilers were of lap seam construction, built in five courses with outside cast iron man-hole frames attached to the third course. Both of them failed through the man-hole frame, and each man-hole course was ripped longitudinally from girth seam to girth seam, through the center line of the man-hole open-

FIG. 1. PATHS OF PROJECTED BOILER COURSES.

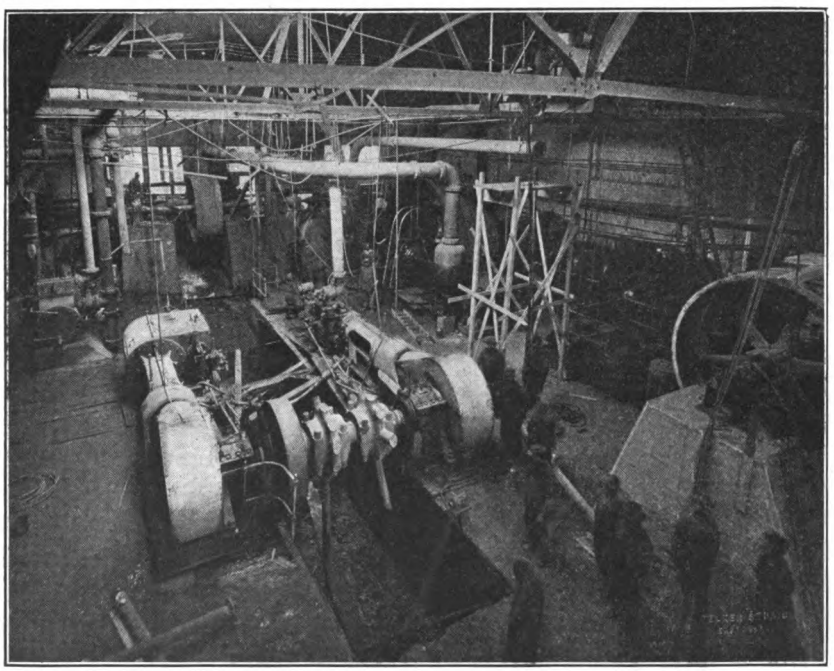
FLY-WHEEL WRECK, ALPHA, N. J.

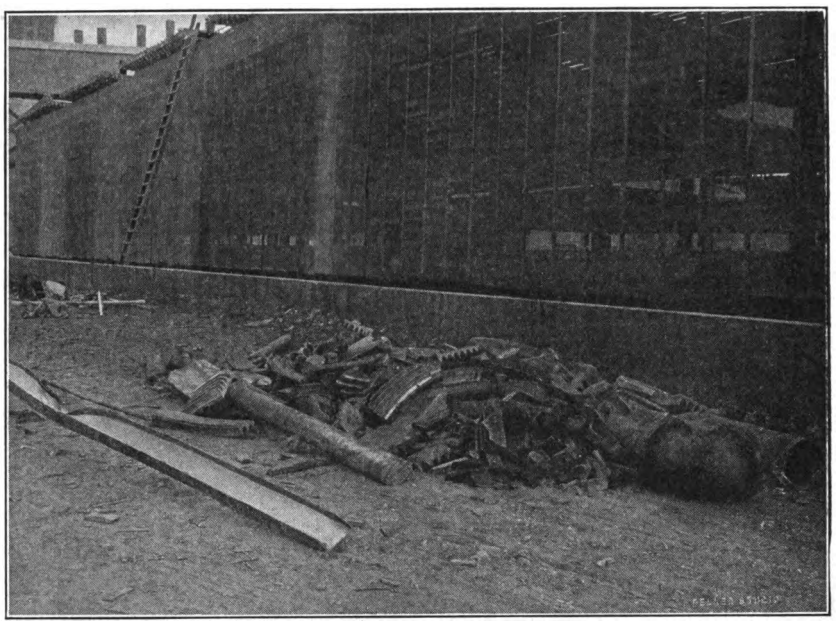
THE REMAINS OF THE FLY-WHEEL, ALPHA, N. J.

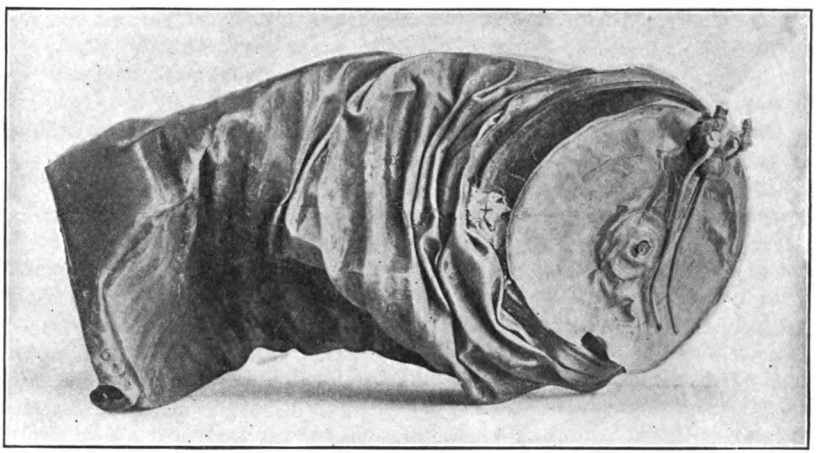
AN EXPLODED PEANUT ROASTING BOILER.

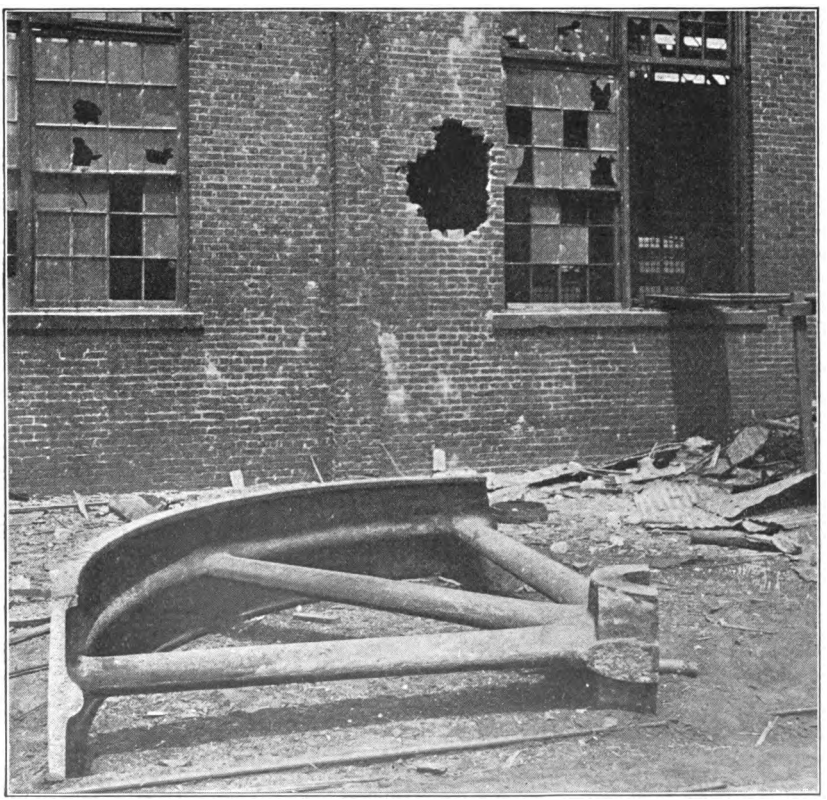
AN UNUSUAL FLY-WHEEL BREAK. BIRMINGHAM, ALABAMA.

We are told that a considerable peak load on the generator caused the circuit breaker to operate, relieving the engine very suddenly. The subsequent racing was noticed by the fireman and he called to the engineer who had stepped out of the engine room. The engineer, realizing what had happened, ran for the throttle, but only succeeded in getting in the path of one of the larger fragments of the wheel. He was instantly killed.

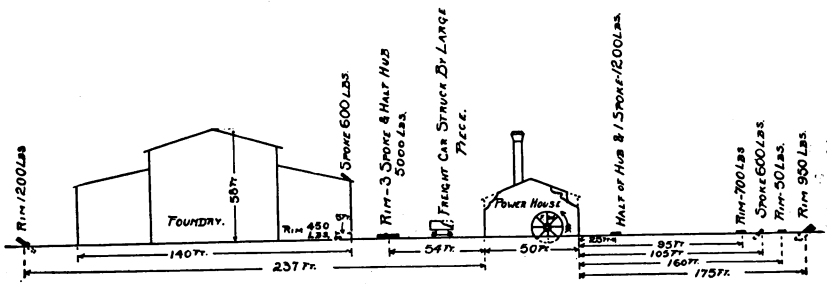
FIG. 1. SHOWING THE COURSE OF THE FRAGMENTS.

Portions of the wheel were thrown both in front and to the rear of the engine, as is shown in detail in our sketch, Fig. 1. The roof and walls of the engine room were badly wrecked, though the roof had been repaired when the photograph Fig. 2 was taken. One large piece passed completely through a gondola car that was standing on a siding alongside the engine room, as our sketch shows.

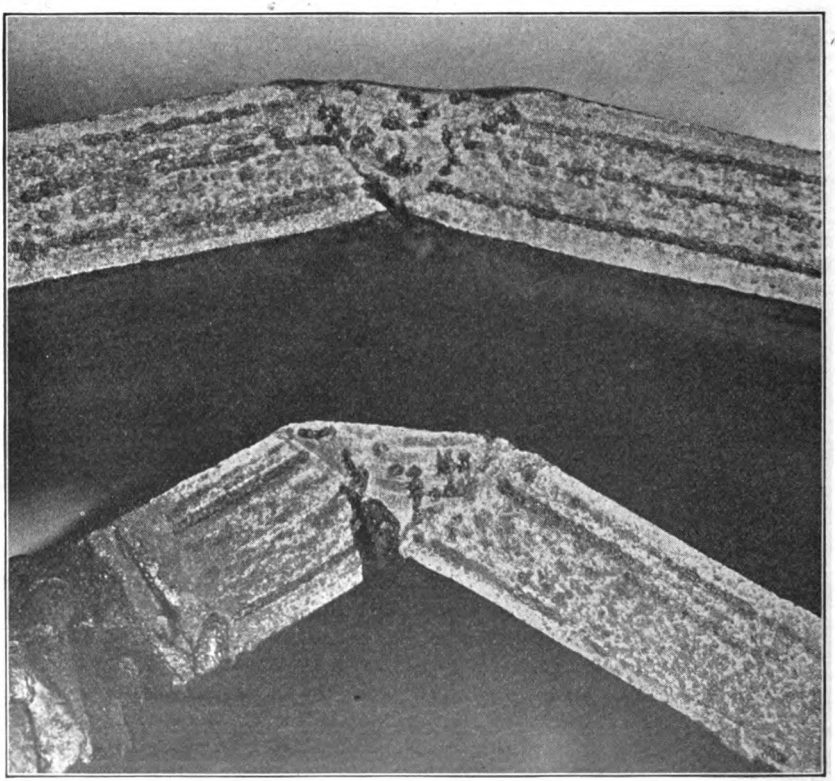
Professor Theodore Kautny of Nürnberg, who is considered one of the leading authorities of the world on this subject, is using his influence to prevent the autogenous welding of boiler shells until some reliable method can be devised for ascertaining the probable strength of a weld without destroying it. We also understand that the United States Government does not approve of acetylene welding for boiler repairs where the parts welded are subjected to tensile strain.

FIG. 1. (Upper.) ETCHED SECTION OF LONGITUDINAL SEAM.
FIG 2. (Lower). ETCHED SECTION OF WELD BETWEEN HEAD AND SHELL.

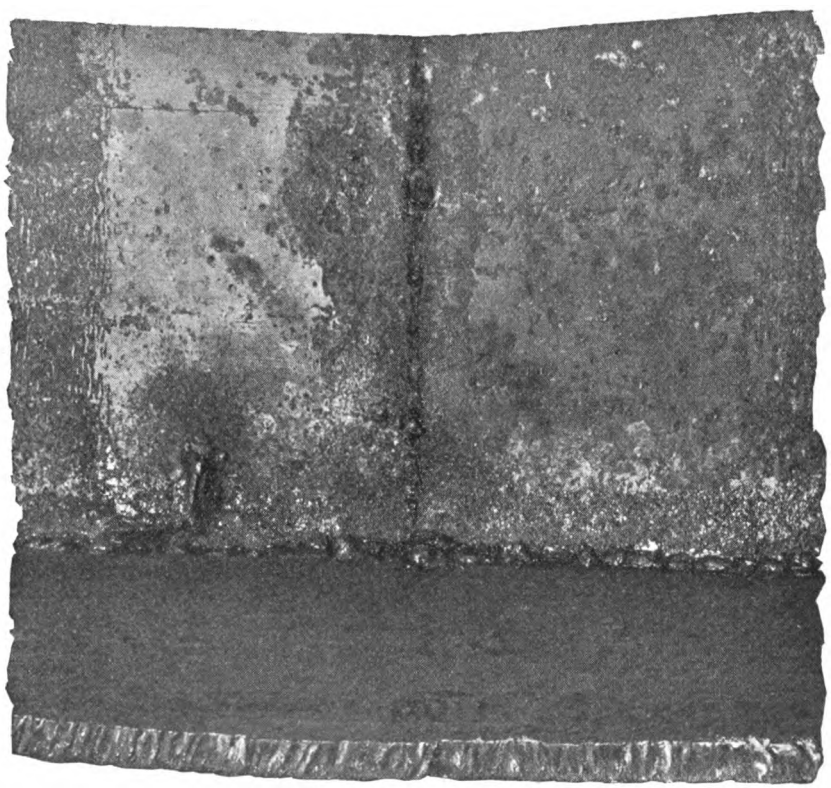
FIG. 3. WELDING OF HEAD TO SHELL. NOTE THE ROUGH CHARACTER OF THE WORK.

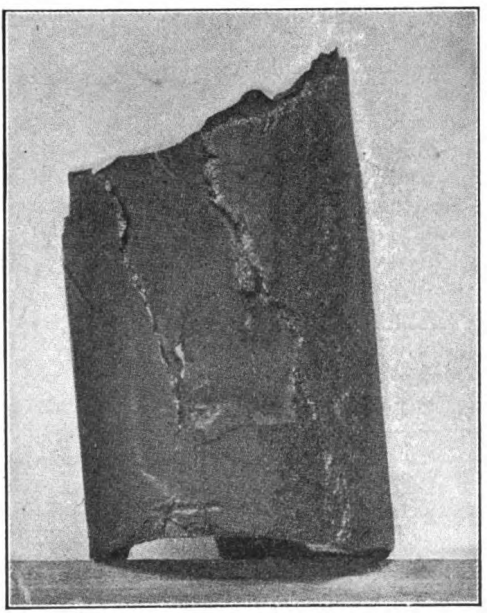
FIG. 3.

In the case in question, the original thickness of the tubes was .080 in., equal to No. 14 standard gauge (B. W. G.) in a section shown in Fig. 1, the thickness of the remaining metal is .012 in. on one side and on the opposite side the metal has entirely disappeared. The thickness of the oxide is .047 on the outer side and .065 on the inner side. The total maximum thickness of the oxide and the residue of metal is .124 in., which it may be observed is considerably greater than the original thickness of the metal, the difference being due to the expansion of iron and steel in the process of oxidation. Therefore 80 to 100 per cent. of the metal has been converted into oxide, and 15 to 20 per cent. remains in its original condition. Fig. 2 shows the irregularity of the oxidized surface, probably due to the current of steam. Fig. 3 shows the black oxidized surface of the metal after the removal of the principal coating of oxide.

In the present case the boiler was heavily worked, and consequently the temperature in the downtake was high. (This refers of course to a Lancashire or Cornish boiler, where the gases pass *down* to the return flues. Editor.) Also only about one-third of the total amount of steam produced was passed through the superheater. By each of these conditions the temperature of the steam as delivered from the superheater would be increased, and in the combined result the temperature of the steam has been raised beyond the point of safety, as shown by the chemical change produced.

The case is a most instructive one, and imperatively shows that superheaters should not be made so large as to involve any risk of causing excessive temperature in the steam, which obviously is attended with grave danger in direct regard to superheater, pipes and engine; also indirectly in regard to the boiler.
